The Infantry Board

No. 1367

GRENADES, AT, M9A1 and M11A1.

SUBJECT: Test of Grenades, AT, M9A1 and M11A1.

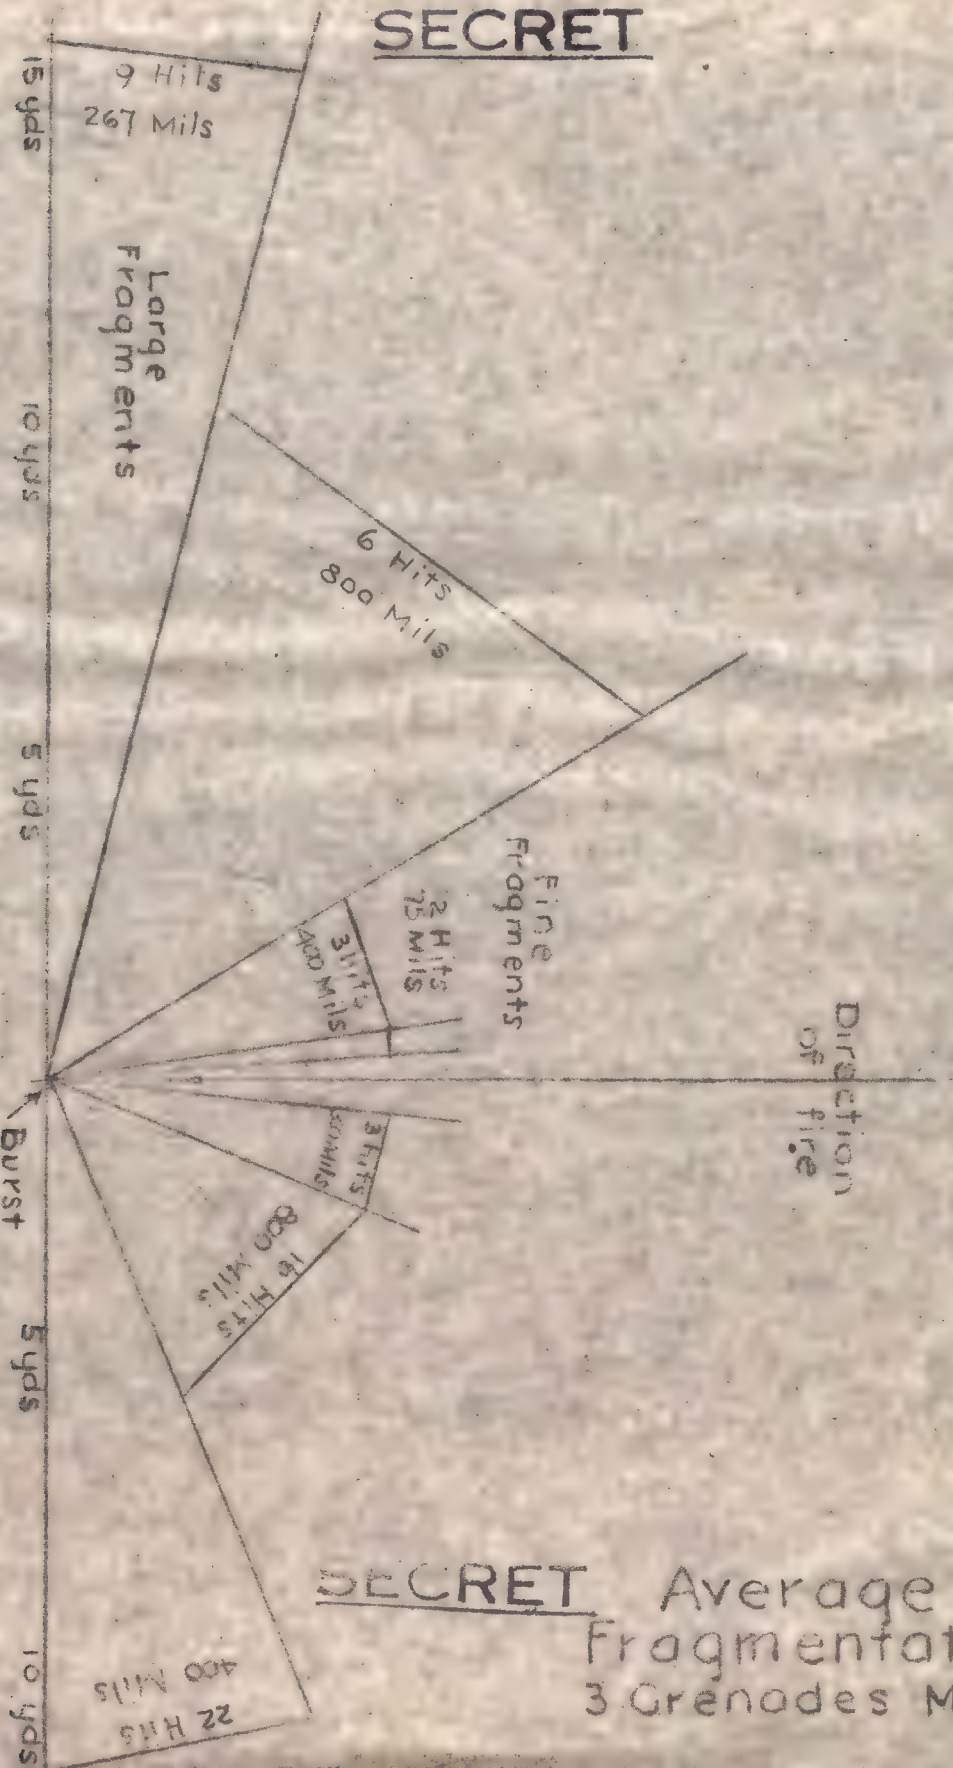
Average Fragmentation
3 Grenades M9 A1

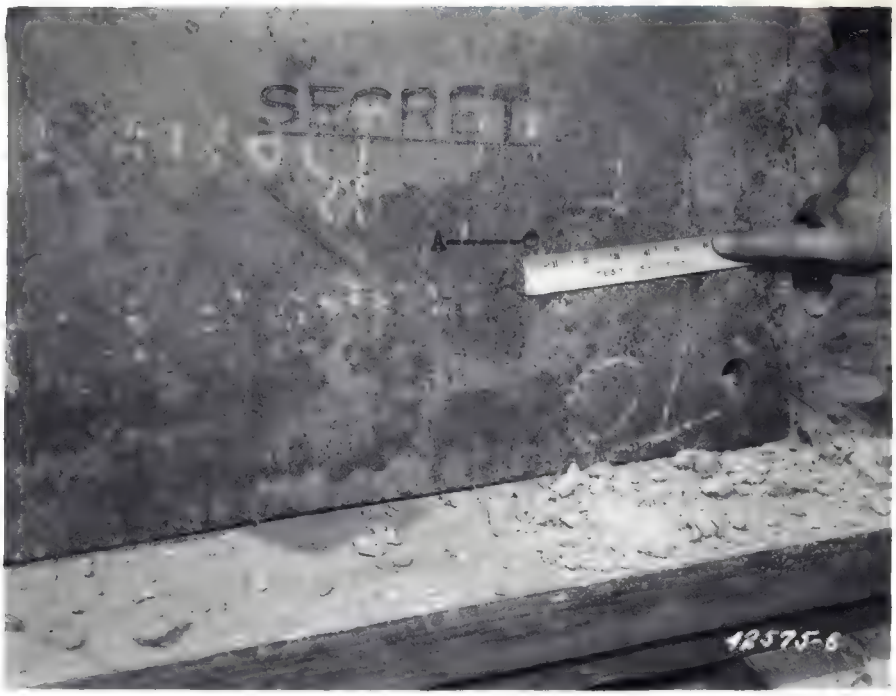
Rear side of the concrete-steel plate.

A - Hole blasted through 1" armor plate, after penetrating 2" of concrete. Made by the M9A1 grenade (pointed ogive).

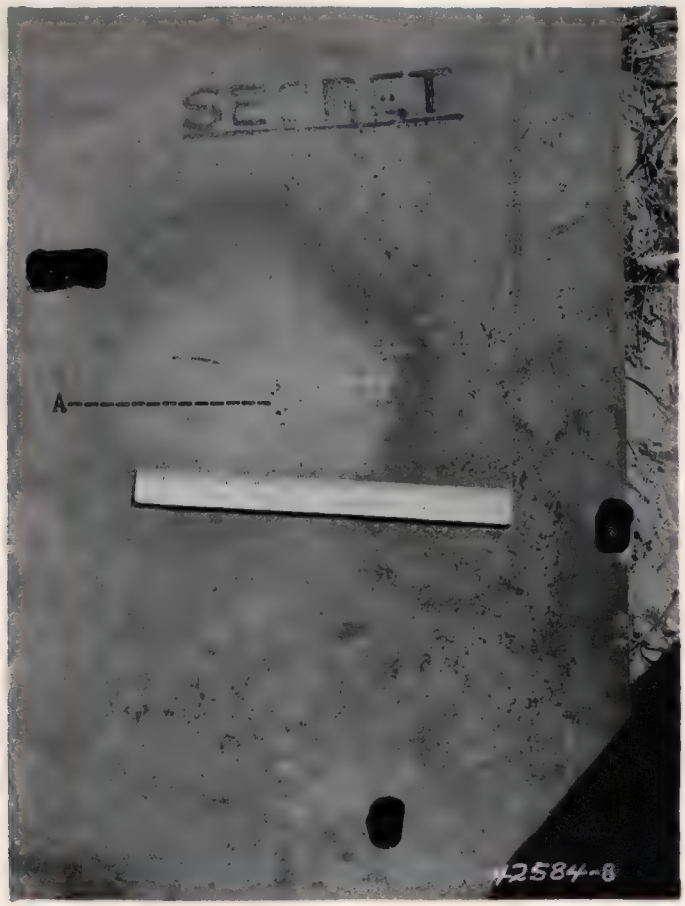
Test No. 4, Paragraph 11.

The 1" plate, set 16" behind the 2" plate.

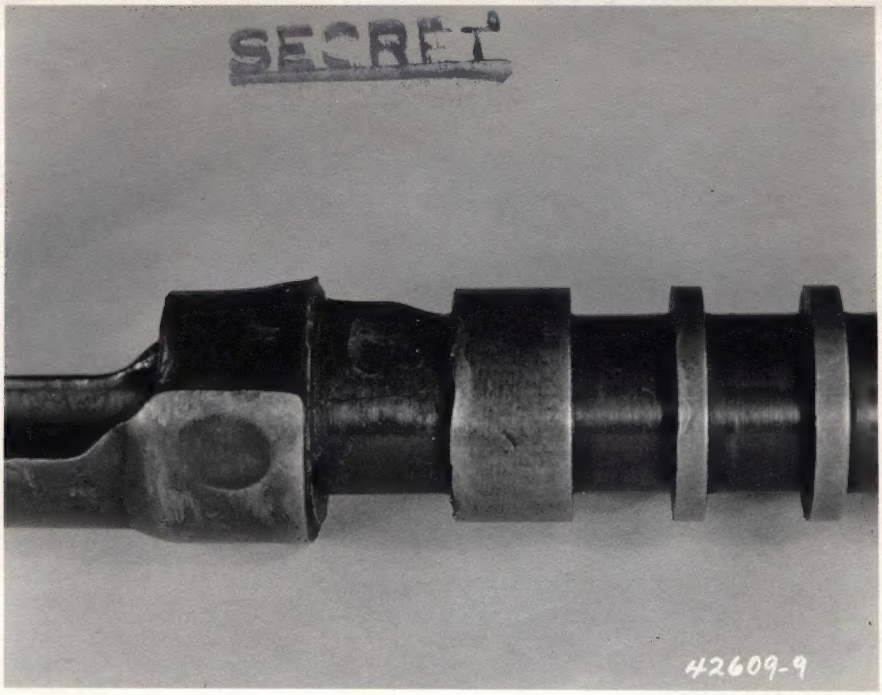
Bulge in M1 launcher. This is the result of firing one round of ball cartridge after the launcher had slipped off the muzzle.

d. This defect in design can be easily remedied by widening the clamping band which goes around the barrel in rear of the sight. Plate 28.

e. Since the rifle in combat will undoubtedly be fired with ball cartridges when the launcher is on the rifle, the Test Section believes that this is a serious defect which should be remedied by redesign. Launchers already manufactured and similar to the one in the possession of the Test Section, should be modified in some simple manner.

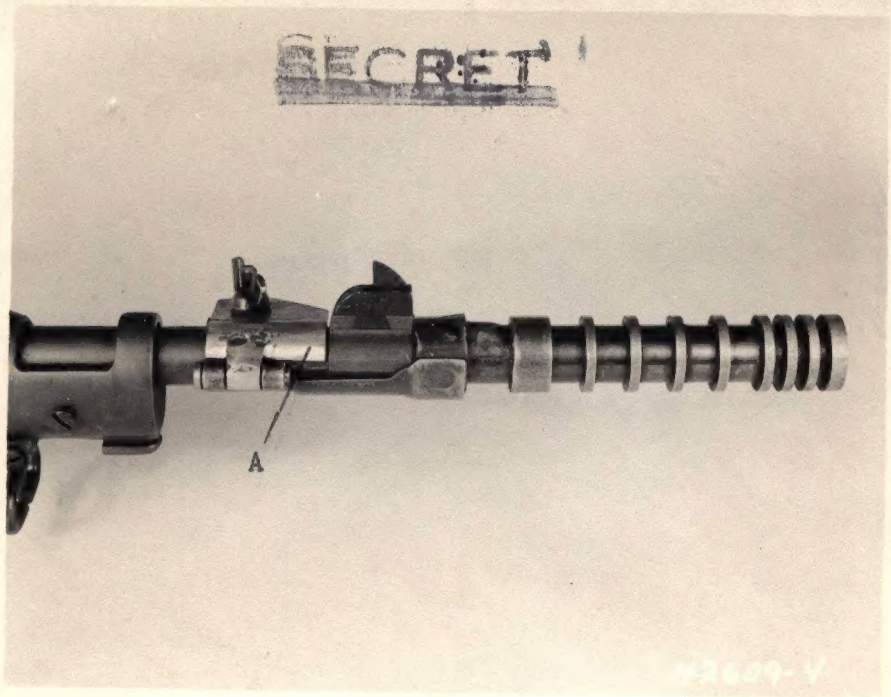
The M1 launcher with modified clamp.

A - Experimental clamp, approximately 7/16" wider toward the front. This prevents the launcher moving far enough forward to slip off the muzzle.
